DEATH AT THE STADIUM

**REPORT ON THE FATAL USE OF AN EARLY STREAMER
EMISSION LIGHTNING ROD IN MALAYSIA**

By
Z. A. Hartono & I Robiah
March 2012
E-mail: zahartono@ieee.org

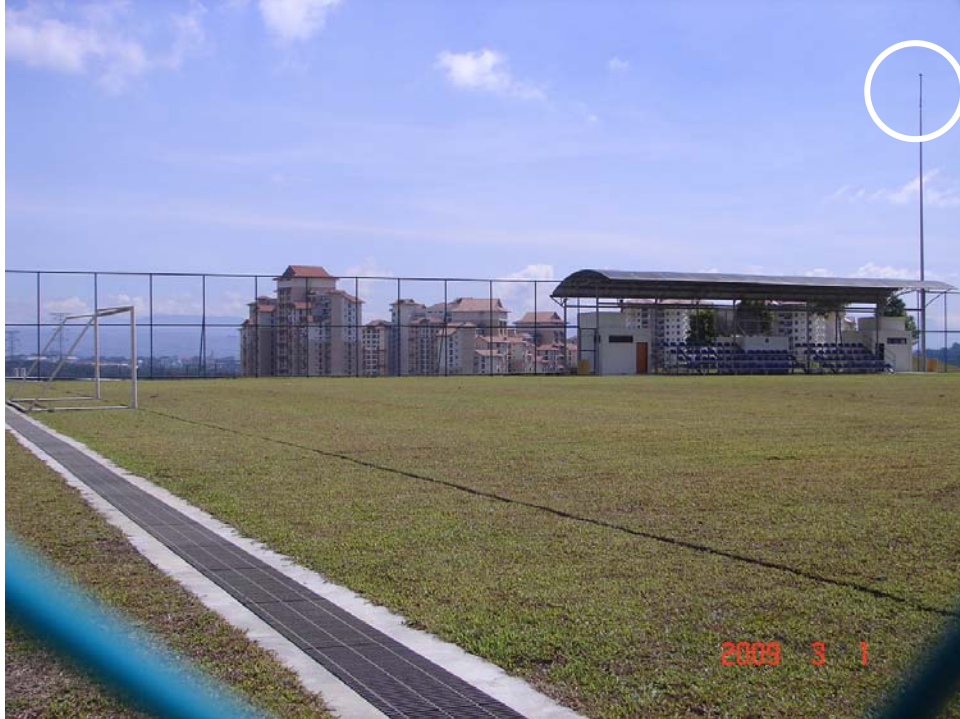
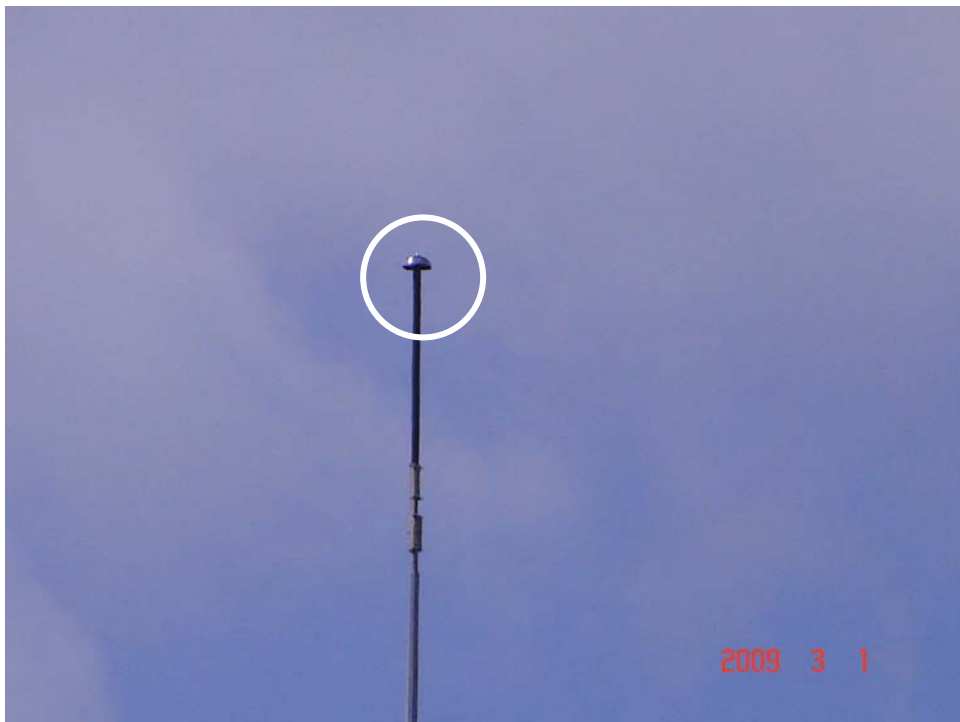
This school field is situated on top of a barren hill and is therefore considered as a high risk lightning location. An ESE lightning rod has been installed beside an all metal mini-grand stand (Figs. 13 and 14).

Fig. 13: An ESE lightning rod installed on a school field in Putrajaya.

Fig. 14: A close-up photograph of the ESE lightning rod.
